Manhole Inspection Summary

Manhole # S37U__005MH

Location Address: **rear 435 e. fort ave**

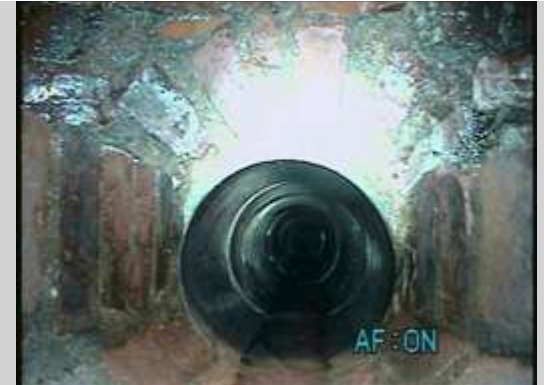
12 O'Clock Outflow

8 in. Circular Gravity Sewer
Pipe Out @ 12 O'Clock

Pipe Material: **Clay** ☐ Pipe Lined

Invert Depth: **9.65** (ft.) Flow Characteristics: **Fast**

Deposits: ☒ None ☐ Mud ☐ Sludge ☐ Debris ☐ Grease

Infiltration: **None** Pipe Seal Cond: **Unknown**

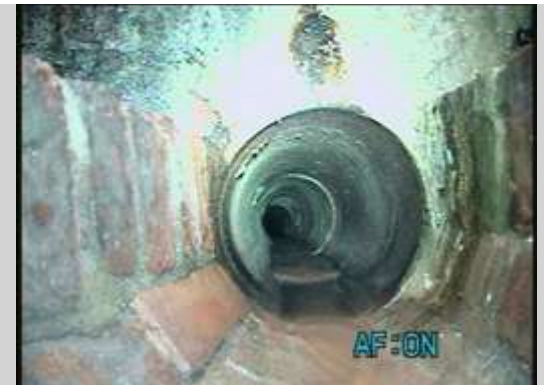
3 O'Clock Inflow

8 in. Circular Gravity Sewer
Pipe In @ 3 O'Clock

Pipe Material: **Clay** ☐ Pipe Lined

Invert Depth: **9.50** (ft.) Flow Characteristics: **Fast**

Deposits: ☒ None ☐ Mud ☐ Sludge ☐ Debris ☐ Grease

Infiltration: **None** Pipe Seal Cond: **Unknown**

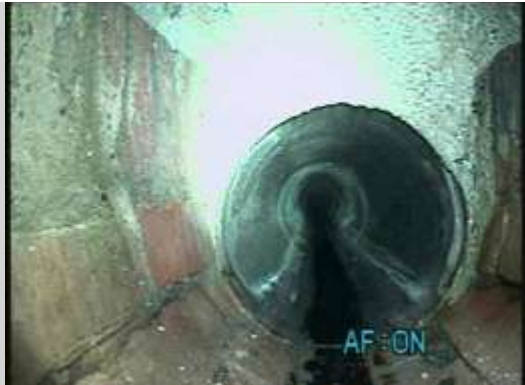
6 O'Clock Inflow

8 in. Circular Gravity Sewer

Pipe In @ 6 O'Clock

Pipe Material: **Clay** ☐ Pipe Lined

Invert Depth: **9.40** (ft.) Flow Characteristics: **Fast**

Deposits: ☒ None ☐ Mud ☐ Sludge ☐ Debris ☐ Grease

Infiltration: **None** Pipe Seal Cond: **Unknown**

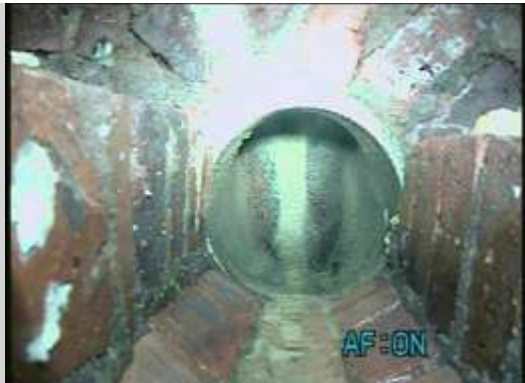
8 O'Clock Inflow

6 in. Circular Gravity Sewer

Pipe In @ 8 O'Clock

Pipe Material: **Clay** ☐ Pipe Lined

Infiltration: **None** Pipe Seal Cond: **Unknown**
